**Flood Control Project Maintenance
Levee Inspections****LMA District Cover Sheet****Spring 2013 Levee Inspection Results****Reclamation District No. 0108 River Farms**

Spring 2013 Levee Inspection Results

Reclamation District No. 0108 River Farms

Levee Inspection Report By Mile - Spring 2013

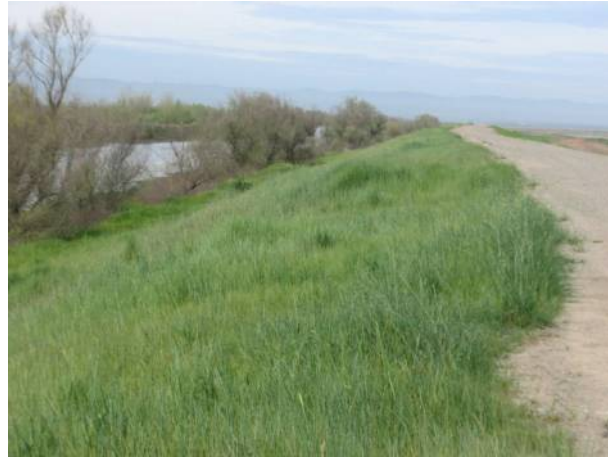
Levee Mile Report Line	4
Start Levee Mile	0.11
End Levee Mile	20.57
Location	Water Side
Category	
Item	Vegetation
The levee has no unwanted vegetation on the slope. Spring 2013	
johnngw_s_20130325_852.JPG

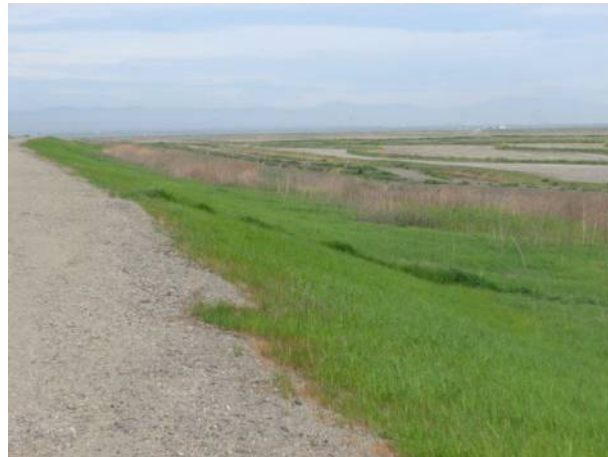
Levee Mile Report Line	5
Start Levee Mile	0.11
End Levee Mile	20.57
Location	Land Side
Category	
Item	Vegetation
The levee has no unwanted vegetation. Spring 2013	
johnngw_s_20130325_853.JPG

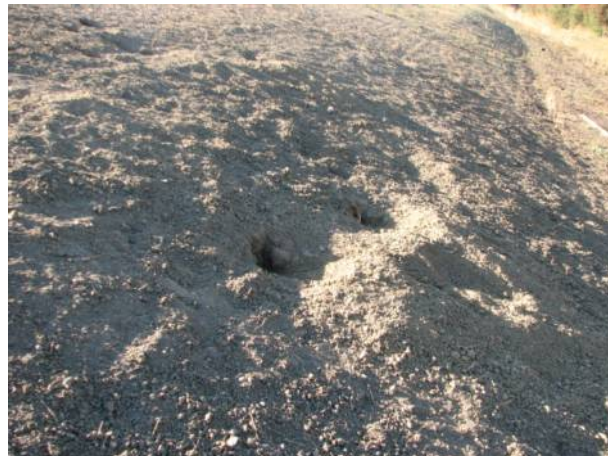
Levee Mile Report Line	12
Start Levee Mile	11.52
End Levee Mile	11.52
Location	Water Side
Category	
Item	Animal Control
Rodent holes on the waterside levee slope. Fall 2012	
johnngw_s_20130221_372.jpg

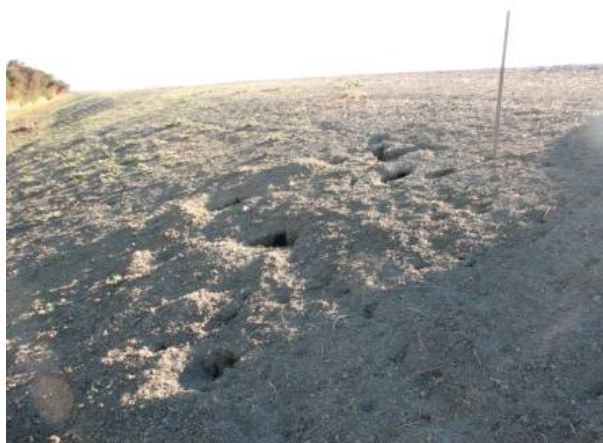
Levee Mile Report Line	12
Start Levee Mile	11.52
End Levee Mile	11.52
Location	Water Side
Category	
Item	Animal Control
A colony of rodents on the waterside slope. Fall 2012	
johngw_s_20130221_373.jpg

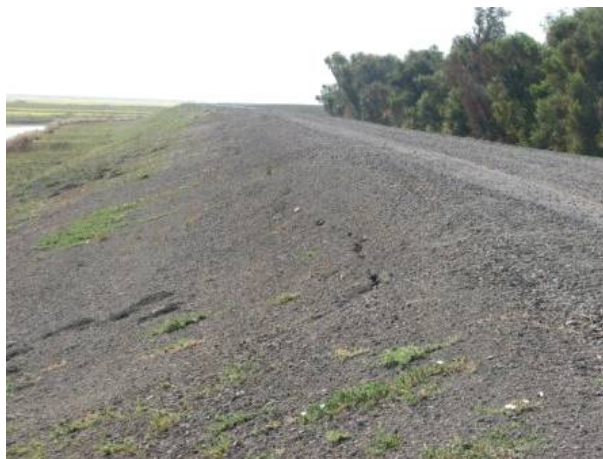
Levee Mile Report Line	13
Start Levee Mile	14.54
End Levee Mile	14.54
Location	Land Side
Category	
Item	Cracking
A crack running along the landside shoulder app. 50' long. Fall 2012	
johngw_s_20130221_374.jpg

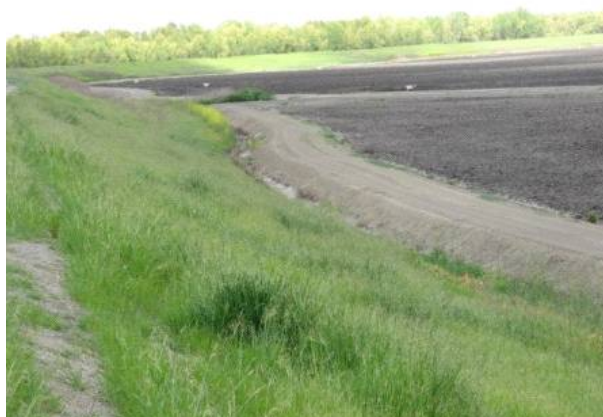
Levee Mile Report Line	14
Start Levee Mile	18.88
End Levee Mile	19.60
Location	Land Side
Category	
Item	Encroachments
Agricultural ditch	
johngw_s_20130221_377.jpg

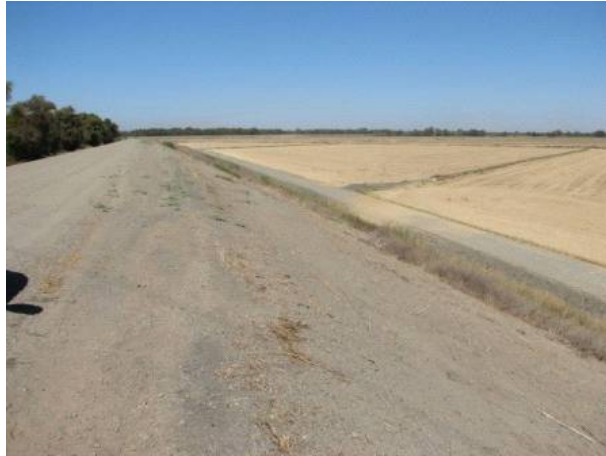
Levee Mile Report Line	14
Start Levee Mile	18.88
End Levee Mile	19.60
Location	Land Side
Category	
Item	Encroachments

Agricultural ditch along toe of landside. Photo taken fall 2011.

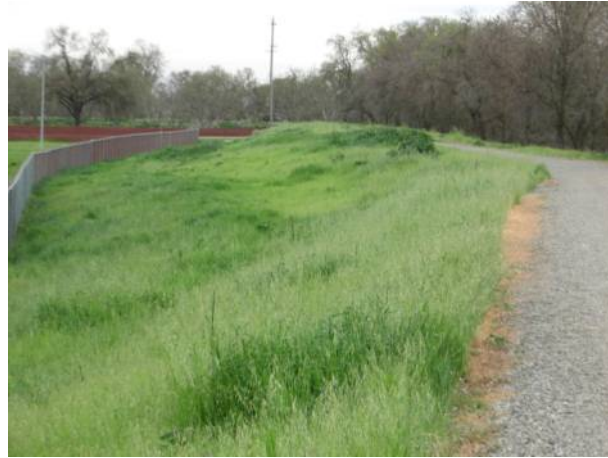
Levee Mile Report Line	1
Start Levee Mile	0.00
End Levee Mile	0.26
Location	Land Side
Category	
Item	Vegetation
The grasses are taller than 12". Spring 2013	
johngw_s_20130325_854.JPG

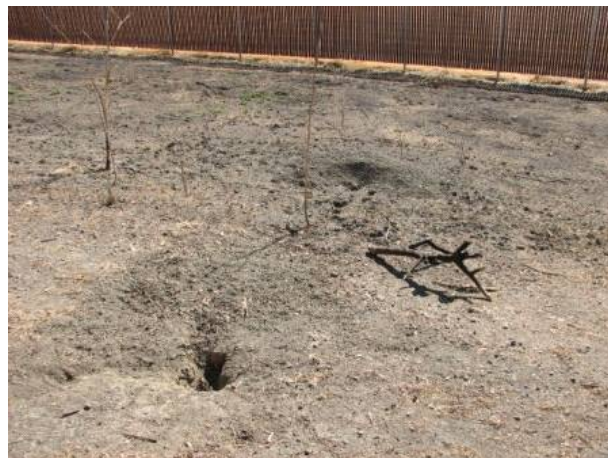
Levee Mile Report Line	3
Start Levee Mile	0.09
End Levee Mile	0.09
Location	Land Side
Category	
Item	Animal Control
A couple of rodent holes on the landside slope. Fall 2012	
johngw_s_20130221_381.jpg
